Ready to operate!

From integrity assessment to repairs, a lot goes into getting an oil and gas terminal facility back in operation. **Rei Wizwan Abdullah Nawawi and Sherman Anthony Nunis, ROSEN Malaysia, explain.**

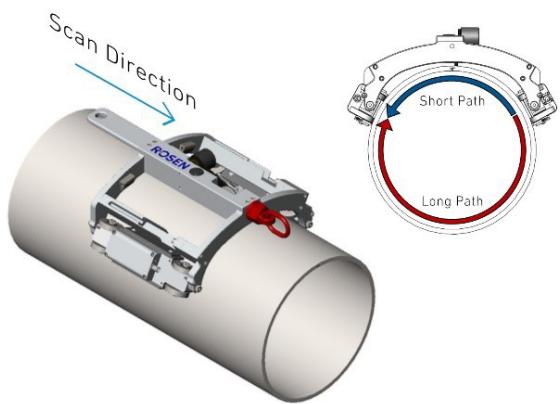
Figure 1. CIRC is suitable for the inspection of the entire pipe body, including its supports and hangers.

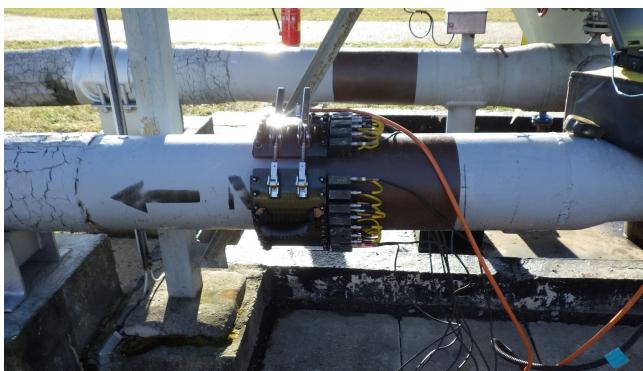
Figure 2. The LRUT collar with multi-mode modules and transducers emits soundwaves that move tens of metres in both directions.
