Enhancing External Corrosion Direct Assessment With Machine Learning

L. BARTON > ROSEN

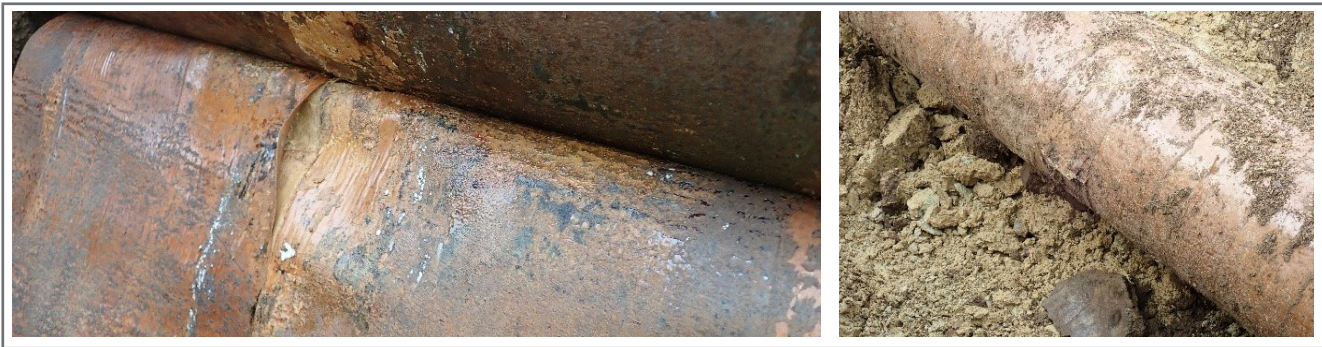
Contrary to the expected design, the coating was found to be a single-layer polyethylene (PE) tape, not bitumen (as per the data provided), casting further doubt on the system records. A single coating defect was noted due to soil loading of the wrap coupled with poor adhesion, as the coating peeled away easily; light surface corrosion was visible on the pipe surface, as well, likely as a result of poor surface preparation during the wrapping process as mill scale was removed and impregnated

within the adhesive. The CP system was confirmed to be working, evidenced by the white hydroxide deposits beneath the coating. Crucially, there was no evidence of corrosion of any significant depth at the location, meeting expectations.

Figure 3: General findings at Location 1

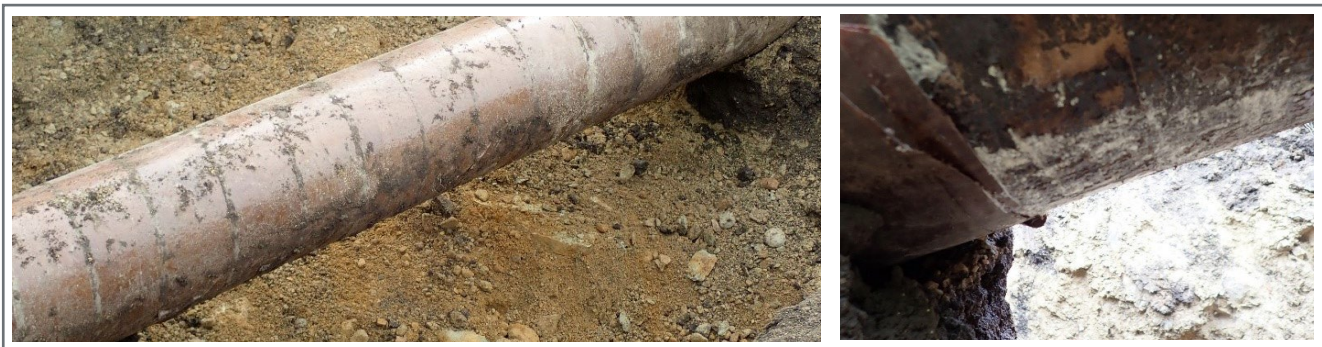
The coating was again found to be a single-layer PE tape, not bitumen. Again, minor coating defects were noted. A single coating defect was found due to insufficient overlapping of the wrap at the 6 o'clock position, coupled with poor adhesion attributed to poor surface preparation during the coating application. The CP system was confirmed to be working, evidenced by the white hydroxide deposits beneath the coating. Crucially, there was once again no evidence of corrosion of any significant depth at the location.

Figure 4: General findings at Location 2

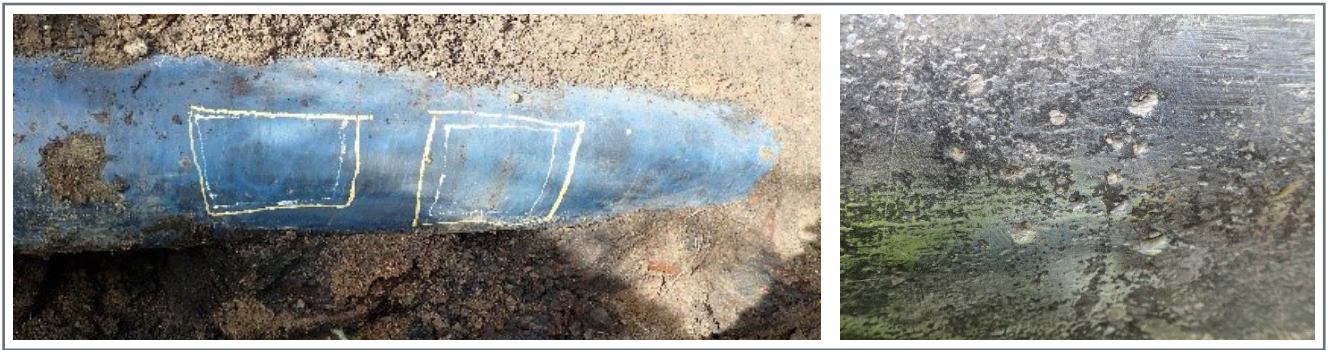
The coating at this location was a rubberized wrap system, not the expected bitumen or the PE tape seen at Locations 1 and 2, casting further doubt on the system records. Minor coating defects were discovered in addition to evidence of poor adhesion, as the coating peeled away easily, and light surface corrosion was visible on the pipe surface at the overlap areas. The CP system was working; however, it was clear some shielding had been present, leading to the formation of some minor corrosion pits < 1 mm deep (< 11% of wt).

Figure 5: General findings at Location 3

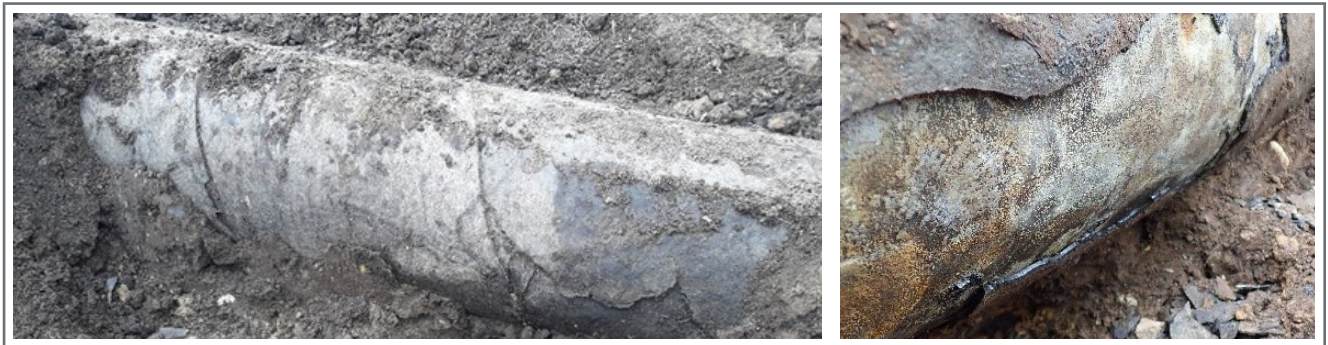
At the final location, the coating was confirmed to be the original 1970s bitumen. Given the relative age of the coating and initial appearances, it was found to be in good condition, with no coating defects present. The bitumen was found to be brittle and easily removed; however, this is to

Figure 6: General findings at Location 4

be expected from bituminous coatings. Following removal of a small section of coating to confirm the condition beneath, the CP system was found to be functioning correctly, with a thin carbonate layer present on the surface and no evidence of corrosion of any significant depth.
