Understanding COMPLEX ANOMALIES

Christopher Holliday, Andrew Wilde and Alasdair Clyne, ROSEN Group, Switzerland, outline the assessment of coincident anomalies in pipelines.

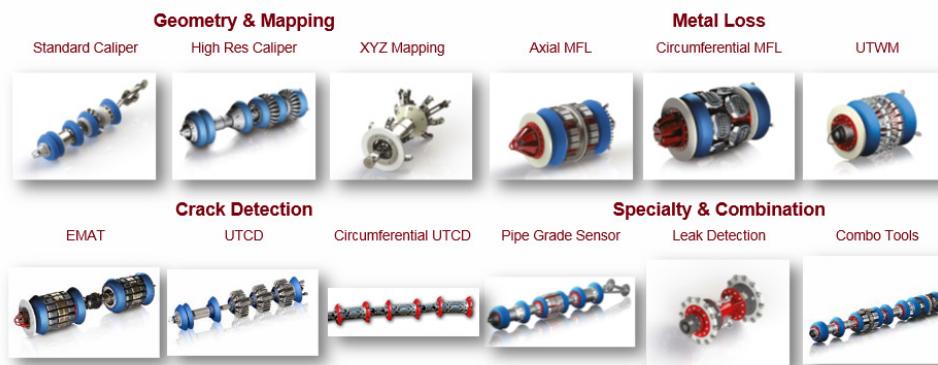
Figure 1. Examples of different ILI tools.

integrity management programmes. Typical ILI tools are shown in Figure 1 and, as the picture makes apparent, there are different types of tools available to detect and measure the dimensions of anomalies associated with the threats referred to in the introduction.

It is worth noting that many of the tools in Figure 1 can be run in combination, thereby saving operators time and money by optimising the number of ILI runs. For example, probably the most common type of inspection is an axial magnetic flux leakage (MFL-A) tool to detect and size general metal loss anomalies, together with a high-resolution caliper (to detect and size deformations) and an inertial measurement unit (IMU) for the accurate location of anomalies and identification of possible areas of bending strain.

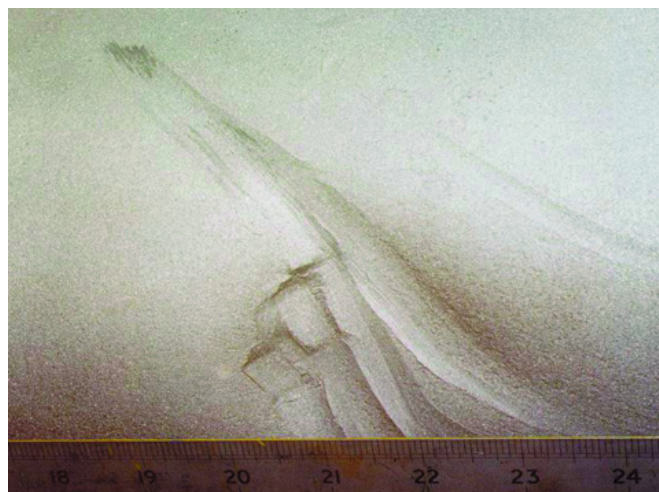
Figure 2. A typical dent-gouge combination.

Probably the most common form of interacting feature is a dent with metal loss. These are typically found by the alignment of data from an MFL-A/caliper combo tool. MFL tools are very sensitive to deformations, and dents can therefore be detected (but not sized) via the ID/OD sensors. Standards such as CSA Z662:19 typically treat a dent associated with a gouge as a defect, and so remedial action is required; however, coincident dents with corrosion may be permitted, depending on their respective dimensions. Consequently, to make a repair decision for a dent/metal loss combination, sizing is required for both anomaly types, but detection and classification are the key requirements to make a repair decision for dent/gouge combinations.

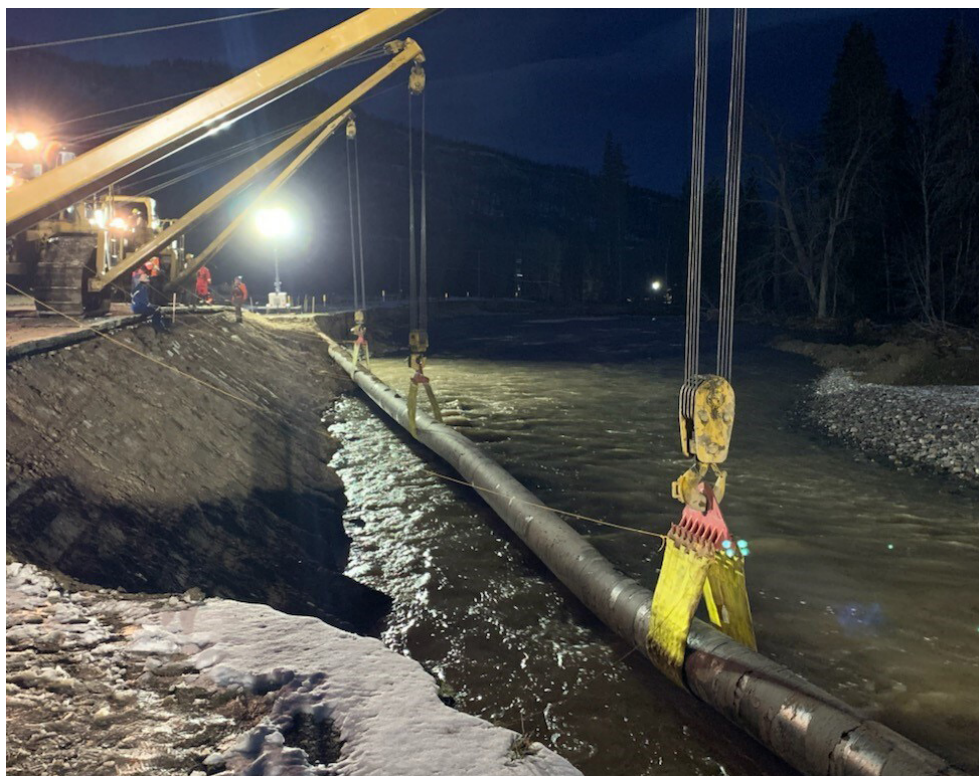
Figure 5. Sidebooms supporting pipe in the Coldwater area.

completely washed away, together with the ground surrounding the pipeline in some areas, leaving the pipeline exposed. As a result, numerous freespans were created, which were initially supported on wooden trestles or via sidebooms once field crews could access the site (Figure 5).
