Enhancing External Corrosion Direct Assessment With Machine Learning

L. BARTON > ROSEN

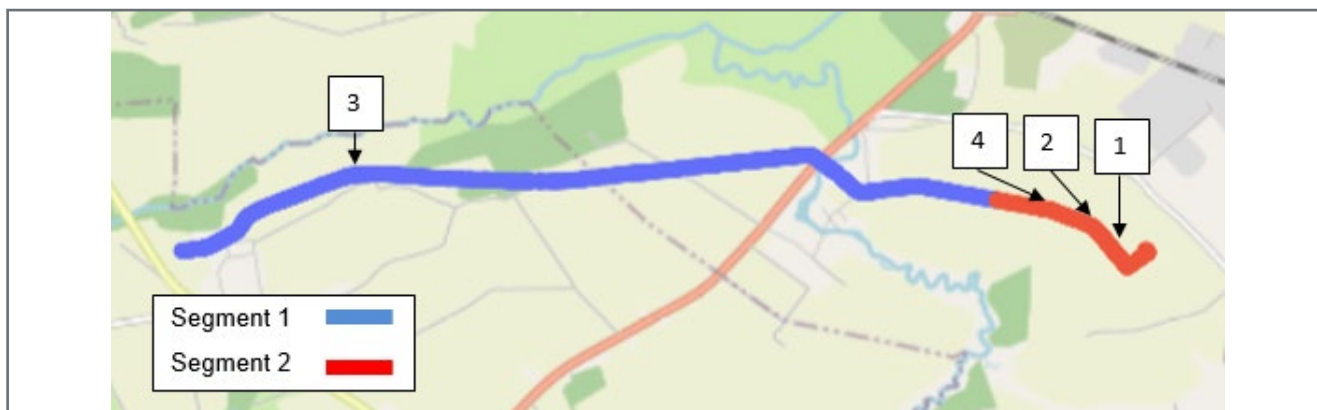
Figure 2: Map showing pipeline route with Segment 1 in blue and Segment 2 in red, plus excavation locations

Location ID	Distance (m)	Segment	Comment
1	7,079	2	Highest combination of factors (CIPS, DCVG and V-ILI)
2	6,953	2	Highest DCVG defect, plus in V-ILI
3	1,147	1	Defect with low-level DCVG in Segment 1
4	6,384	2	Control site in V-ILI Segment 2
