Coiled Tubing Inspection Services

Automatic Coiled Tubing Integrity Monitoring (ACIM)

ROSEN-Group_Serviceflyer_ACIM_v1-0_2024

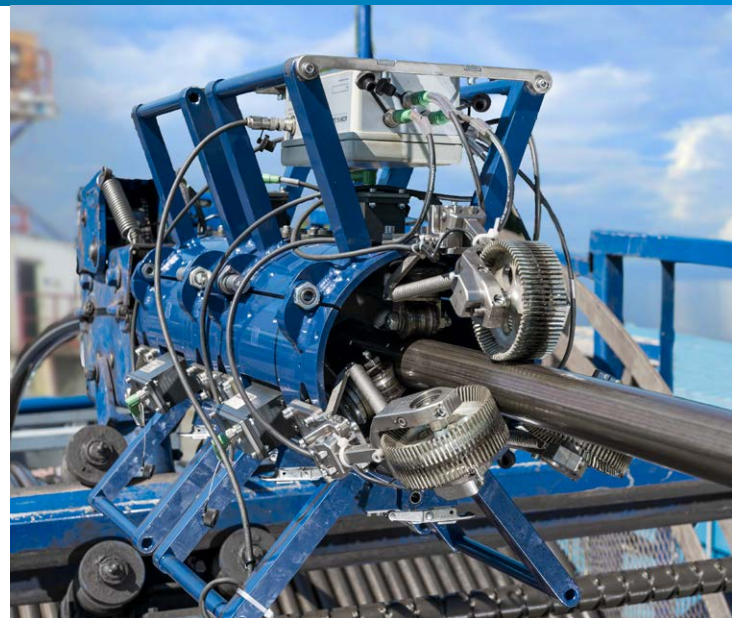
ACIM inspection head clamped on coiled tubing

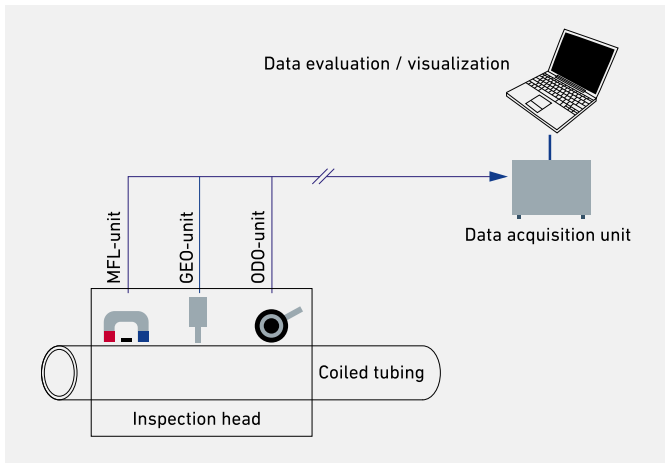
The ACIM inspection unit contains:

- A circumferential array of up to 54 integrated magnetic flux sensing hall elements
- 12 GEO sensors for measuring tube geometry (ovality)
- An odometer for logging the position of detected features.

ACIM tool components

ACIM is based on Magnetic Flux Leakage (MFL) technology, a nondestructive testing method that can detect metal loss in coiled tubing. The wall of the tube is magnetized and the magnetic field leaks from areas where there is metal loss. This leakage field is then detected and assessed in real time.

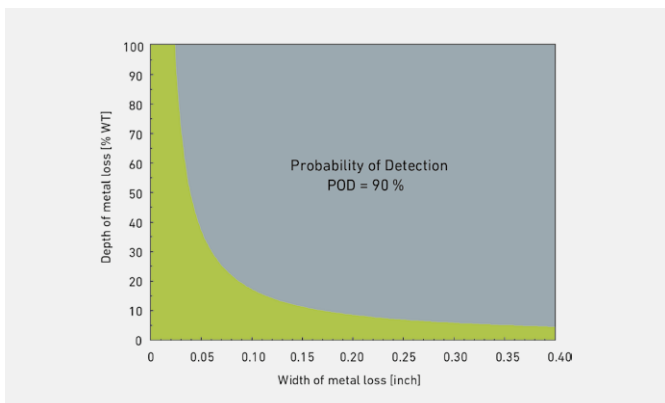
Figure 1 shows the minimum depth of surface flaws (as a % of wall thickness) vs. the width of metal loss that can be detected automatically. The shaded area represents a probability of detection (POD) at 90 % certainty. The ACIM system magnetizes the tubing in the axial direction.

The system can automatically detect transverse flaws and three dimensional defects such as cracks, cuts and general corrosion. Corrosion in the longitudinal direction will be detected if the defect has a sufficient transverse component to cause a detectable change in magnetic field.

see POD table above	
Min. transverse Notch Detection (LxWxD)	6,35mm [0.25"] x 0,5mm [0.02"] x 10%
Thinning (LxWxD)	30mm [1.2"] x 25mm [1"] x 1,5mm [0.01"]
