RoCombo MFL-C / XT Service

In-line Combined Axial Feature and Geometry Analysis

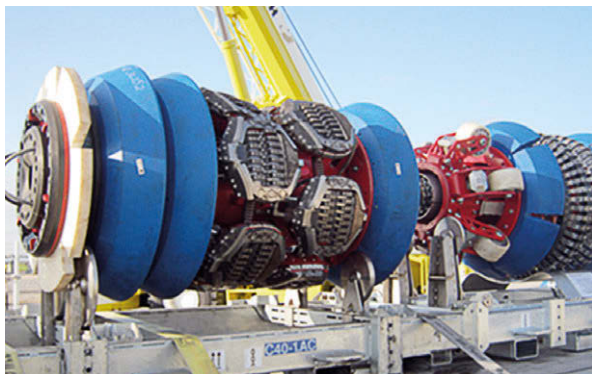
The RoCombo MFL-C/XT includes not only a Magnetic Flux Leakage unit but also a combination of mechanical calipers with an electronic measurement system based on the Eddy Current principle. This innovative combination enables the RoCombo to check for both, metal loss and geometry anomalies in only one inspection run. Unique magnet and sensor designs ensure high sensitivity and precision for the detection of corrosion, erosion, gouging and a huge variety of other metal loss features.

The tool measures depth, profile and contour of geometric features, allowing a stress/strain based integrity assessment. XYZ mapping coordinates for advanced integrity management is available optionally.

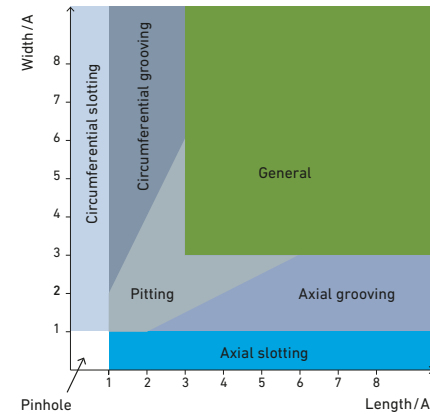
All reported metal loss features are classified according to the dimensions shown in the following Pipeline Operators' Forum (POF) specification graph.

A = wall thickness or 10 mm (0.39"), whichever value is greater

Metal Loss Feature Classification
